# ACTION GUIDE Erosion hazard assessment after a fire

Experimental arrangement in the commune of Cerbère (Pyrénées-Orientales, France)

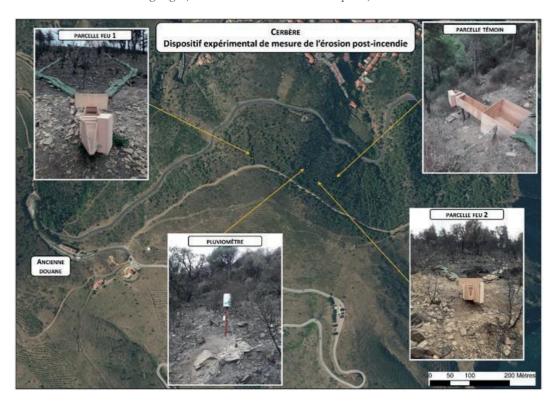
Area	Longitudinal slope	Distance to rain gauge	Type of vegetation
Fire Plot 1	115 m <sup>2</sup>	44%	130 m	Shrubby scrub
Fire Plot 2	107 m <sup>2</sup>	53%	40 m	Dense shrubby scrub
Control Plot	114 m²	56%	70 m	Dense shrubby scrub

The three erosion plots were identical, and consisted of:

- a plot of land with an area of approximately 100 m<sup>2</sup> delimited by boundary markers laid and packed into the natural ground (this choice of marker was needed because the ground is very stony and thin curbs cannot be easily inserted). The boundary markers at the bottom of the plot converged to channel the water to the measuring device;

- a wooden **sedimentation tank** with a side length of 80 cm which receives the run-off. Coarse material (sand and stones) and plant debris settle in this tank;

- a 1.2 m long **approach channel** to channel the flows,
- a 0.8 foot Hs-Flumes flowmeter with its remote measuring well. The measuring well is fitted
  with a water level logger (Level TROLL 500 from InSitu). The specific shape of the flow
  meter reveals the flow rate based on the measured water level;

- an **automatic camera** (time lapse and motion detection) to record the flows coming out of the flow meter.
